Cockatoo Island Seawall Seepage Barrier

Russell J. Denny, Wagstaff Piling Pty Ltd, and Chris L. Powell, Pluton Resources Ltd.

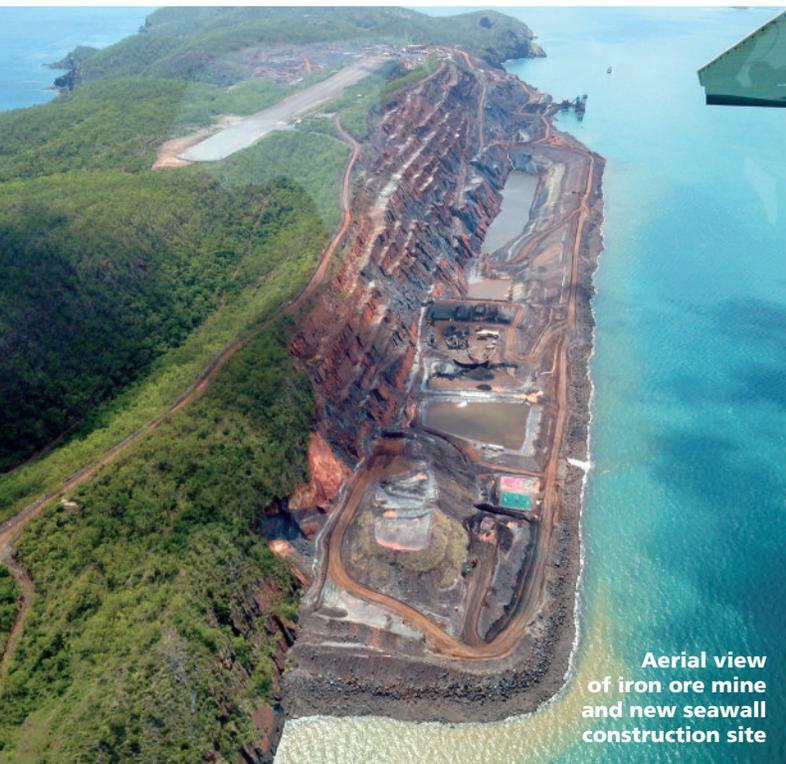
Aerial view of iron ore mine and new seawall construction site

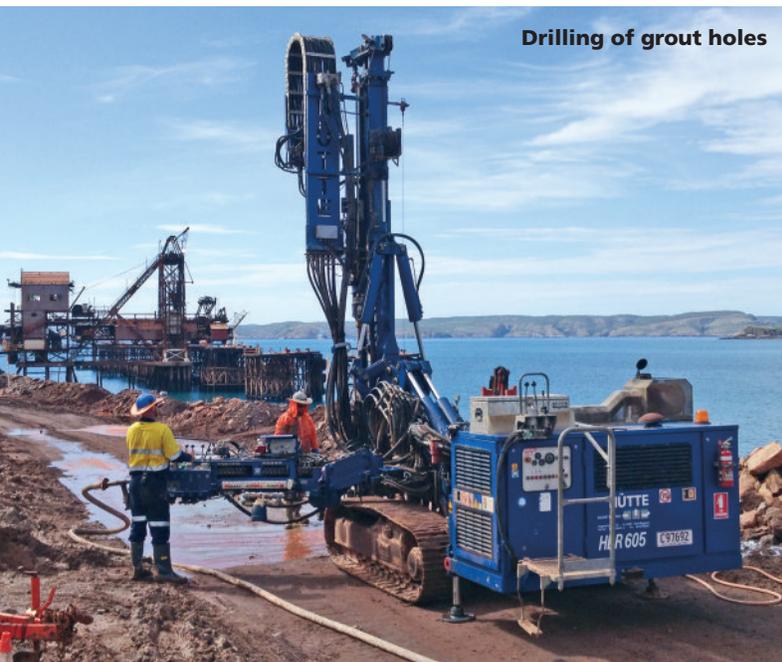
Drilling of grout holes

A line of grout holes at a center-to-center spacing of about 1 m (3.3 ft) was proposed to form the seepage barrier, with grouting extending to a depth of about 17 m (56 ft) below the top of the seawall. Top hammer drilling techniques were used to penetrate the 12 m (40 ft) deep rockfill to seabed level, and permeation grouting carried out within the rockfill to fill voids and stabilize material around grout holes. The local 10 m (33 ft) high tidal fluctuations meant that tidal washout of fines and grout would be a major risk, and so a combination of cementitious and chemical grout was used to create rapid gel times.

Top hammer drilling proved to be similar to that anticipated in the area of the new seawall construction, although large portions of the grout alignment turned out to be located over tapering transitions to the existing seawalls. In these transitions, large

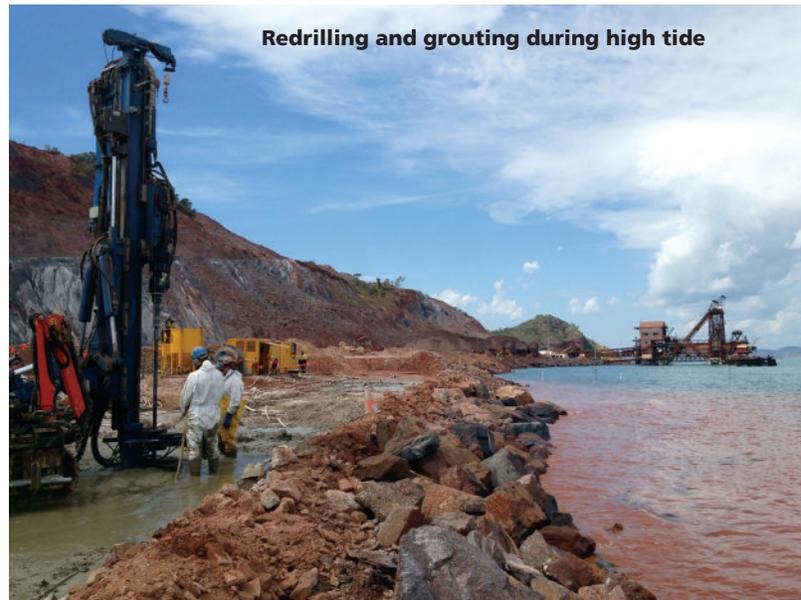
Redrilling and grouting during high tide

Borehole stability was difficult to achieve in the often loose rockfill. Many top hammer drilled holes needed to be redrilled and grouted a second time to create the stable passage for the later jet grouting. The rapid gelling properties of the sodium silicate and the cement grout mix were essential to achieve a collared and stabilized hole through the rockfill, especially with the large volumes of tidal seawater flowing continuously in and out as the tides changed, and, more particularly, during the spring tides where a 10 m (33 ft) tidal variation would occur during a 6 hour period.

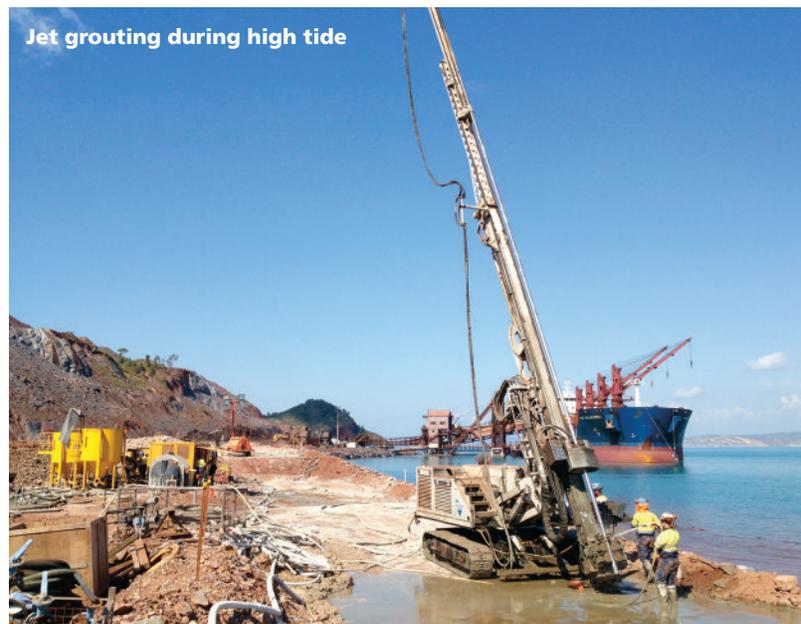
Jet grouting during high tide

Following the permeation grouting, the collared boreholes were reopened to perform jet grouting using the duplex system in a single pass. Initially, the jet grouting was focused below the seabed to provide the cutoff through the highly permeable coral reef debris and into the Coralline Sediments. Subsequently, the jet grouting was extended upwards to within 2 to 3 m (6.5 to 10 ft) below the working surface to overlap the permeation grouting into the seawall fill to overlap with the earlier permeation grouting.

Jet grouting proved to be very effective in the sediments beneath the upper seawall rockfill, which was reflected in the volume and nature of the uphole circulation (returning fluid) during the jet grouting. The returning volumes up through the seawall fill over successive phases of grouting provided similar initial indications and confidence of filling of the void spaces and of achieving continuity between grout columns at depth.

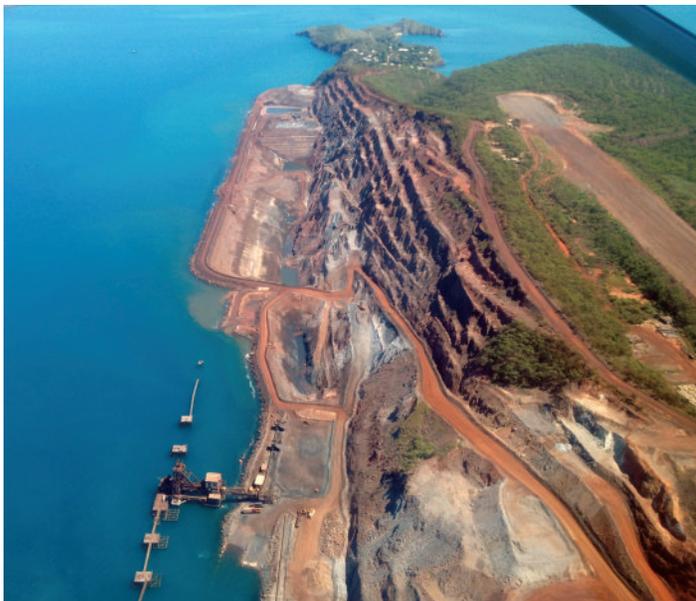
Aerial view of dock and seawall construction site

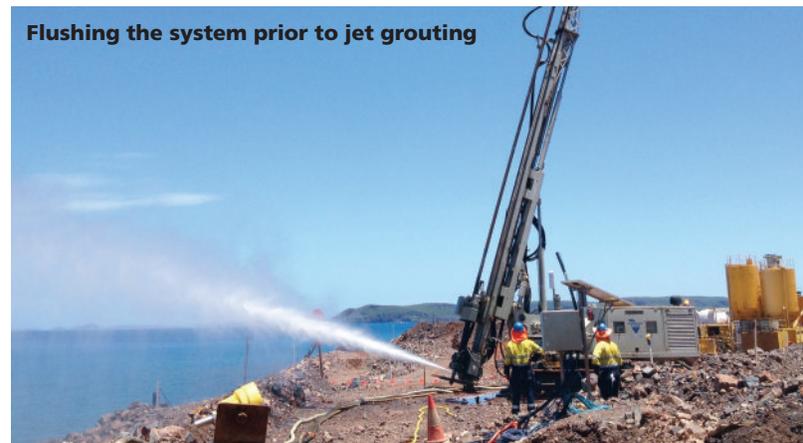
Flushing the system prior to jet grouting

The injected grout mix comprised a combination of hydrated bentonite with cement and water at a water-to-cement (w/c) ratio of 0.98, with a cement content of 763 kg per cubic meter (47.6 lb per cu ft) and a bentonite content of 15 kg per cubic meter (about 1 lb per cu ft) of mix. The jet grout was installed using the duplex system, with air injected at a pressure of 8 to 10 bar (116 to 145 psi) and grout injected at a pressure of 300 bar (4,350 psi). Typical installation technique and parameters included flushing downwards at low pressure (no jetting) and then jetting upwards at

a pressure of 300 bar (4,350 psi), with an approximate grout flow of 230 liter/min, an upwards velocity of 25 cm/min (0.8 ft/min), and a rotational velocity of 6 to 8 rpm. The jetting nozzles used were 2 x 3.5 mm (2 x 1/8 in) in diameter, the typical targeted jetting energy was 40 MJ/m, and the aim was to achieve a grout column of 1.2 to 1.5 m (4 to 5 ft) in diameter.
